Manhole Inspection Summary

Manhole # S53W1_003MH

Insp Date: **5/29/08 11:01 AM**

Location Address: **1901 Chesapeake Ave.**

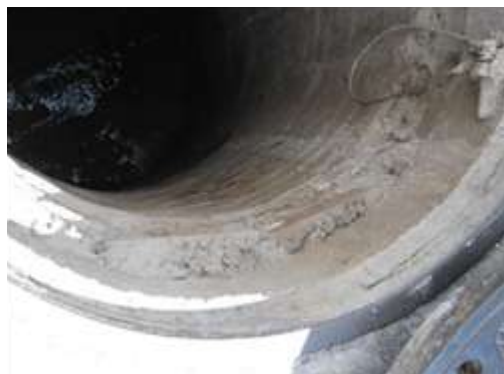
Defect 1

Offset: **2** (in.)

Frame offset

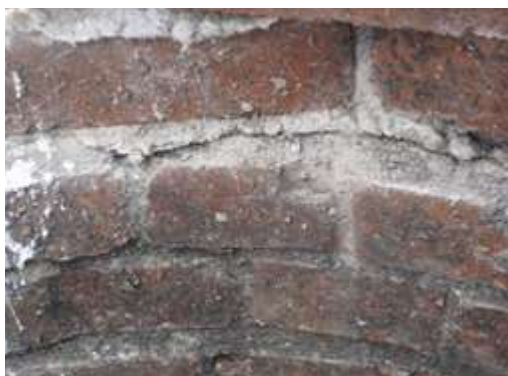
Defect 2

Condition: ☐ Sound ☒ **Cracked** ☐ Root Intrusion ☐ Loose Brick ☐ Deteriorated

Cracked Corbel

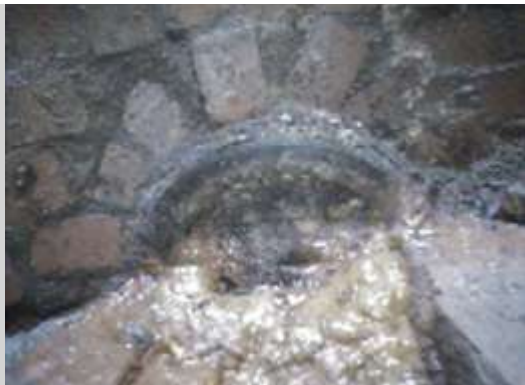
4 O'Clock Inflow

Unable to measure influent pipe @ 4 O'clock due to blockage

Pipe Height: **3.6** (in.) Rod and Bar (Angled)
Pipe Material: **Clay** ☐ Pipe Lined
Invert Depth: (ft.) Flow Characteristics: **None**
Deposits: ☐ None ☐ Mud ☐ Sludge ☒ **Debris** ☐ Grease
Silt Depth: **0** (in.) Deposits Extent: **Heavy**
Infiltration: **None** Pipe Seal Cond: **Sound**

Connects To: **Stub connection / abandoned**
